FINAL REPORT

WATER LEAK DETECTION PROJECT

Project Location:
Century Village East
Deerfield Beach, FL

Prepared by:
Utility Services Associates, LLC
916 W. Center St.
Kalispell, MT 59901

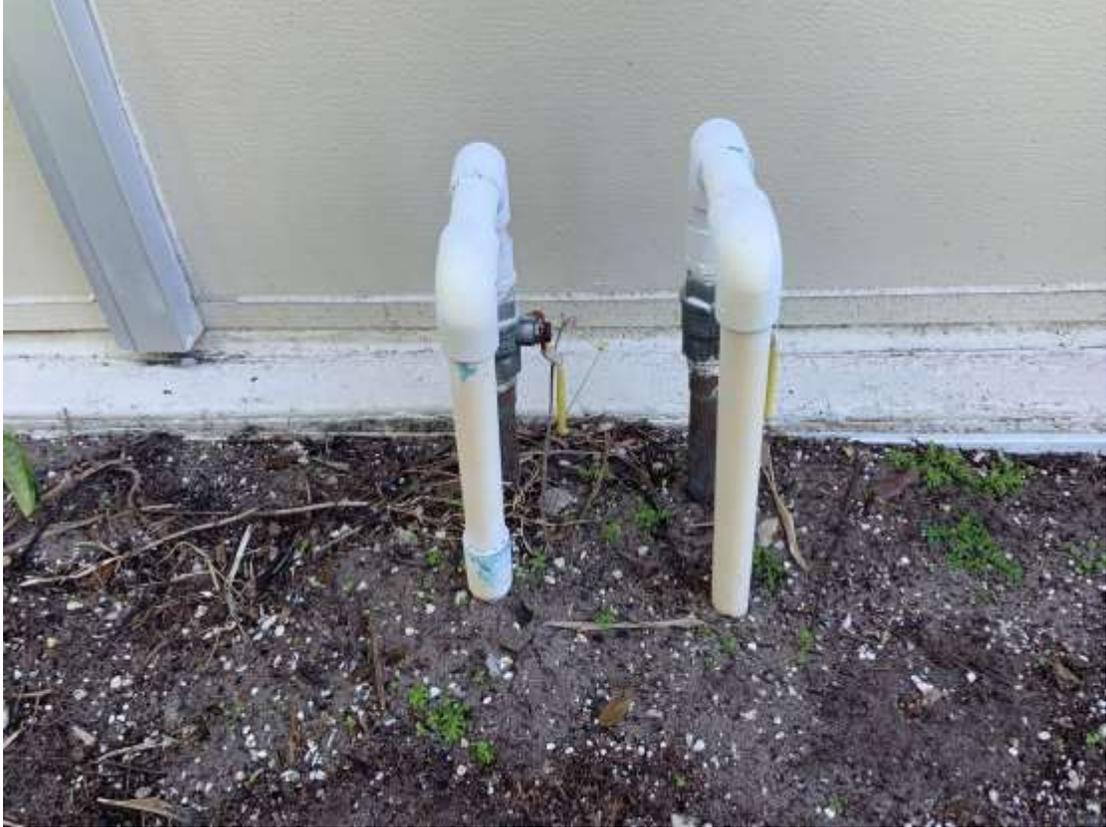
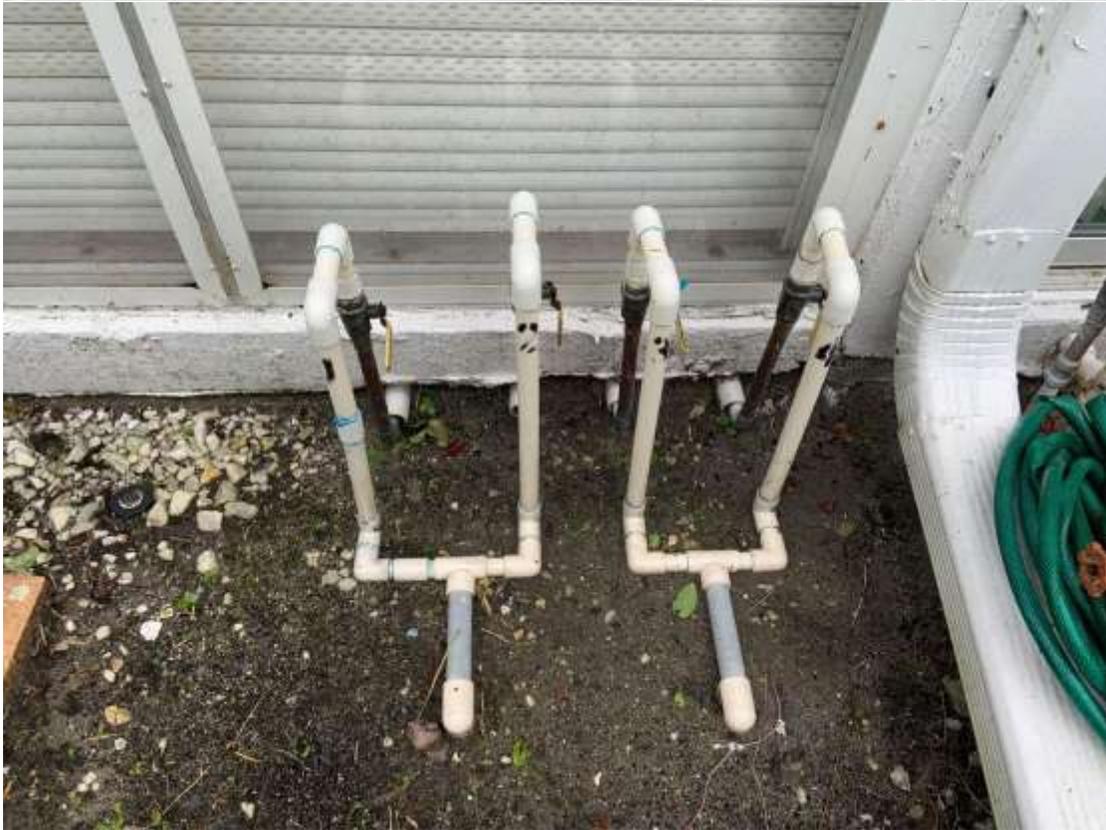
The shutoff valves for each unit are located outside on a standpipe, either directly in front of or behind the units. They are clustered in groups of either two or four shutoffs. The shutoffs that are in two's are for the two-story buildings with one shutoff in the pair being for the bottom unit and the other shutoff being for the unit directly above the bottom unit. The shutoffs that are clustered in groups of four are for the four-story buildings with all four of the shutoff standpipes being for units directly above one another. Each building has numerous residences with multiple shutoff clusters spread along the length of each building. The lines that feed the residential buildings are 3" PVC lines which called for a point-to-point survey with a sounding at each shutoff cluster so as not to miss any leaks. This added significant time spent on this project. The images below give an example of what the shutoff standpipes look like for the two-story and four-story buildings.

Note: In the image above for the four shutoff standpipes to the four-story buildings, the lower section of the pipes showing how the lines split are not typically exposed but are covered in the soil in most cases in the village. This photo is a rare but good example that shows how the lines run off the 3" PVC main that runs nearby.
