## Century Village East Master Waterway Inspection Report

**Reason for Inspection:** Routine Scheduled

**Inspection Date:** 2024-04-10

Century Village East Master Management  
Mr. Robert Streater  
3501 West Drive  
Deerfield Beach, FL 33442

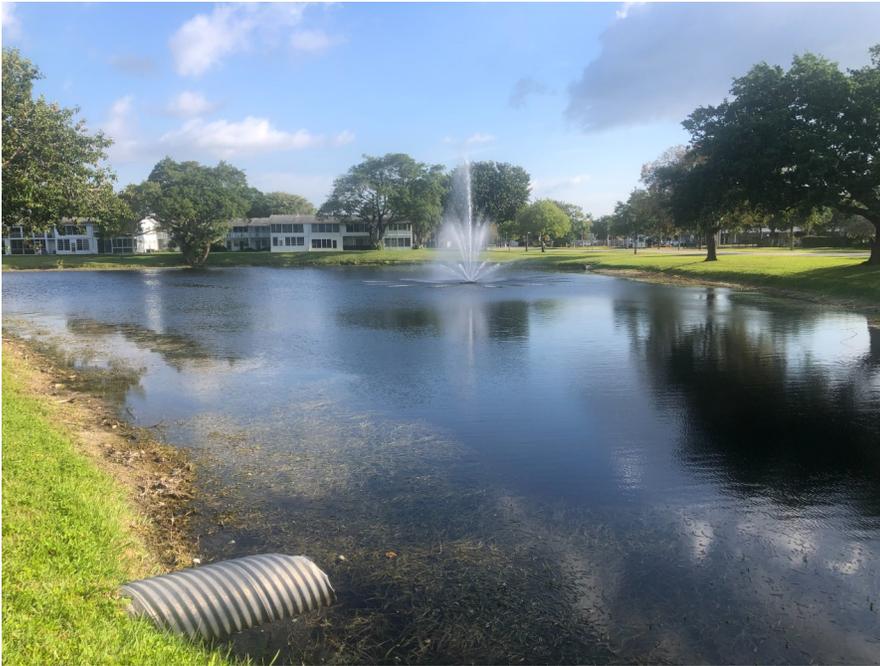
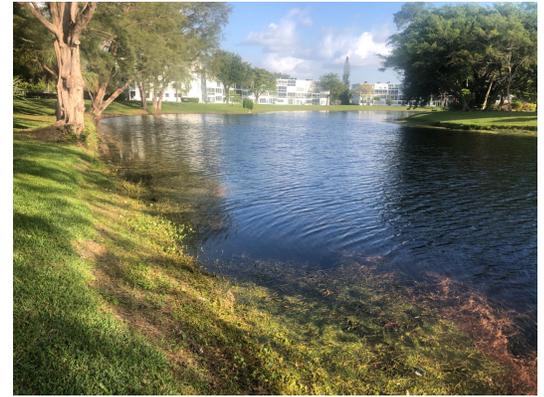
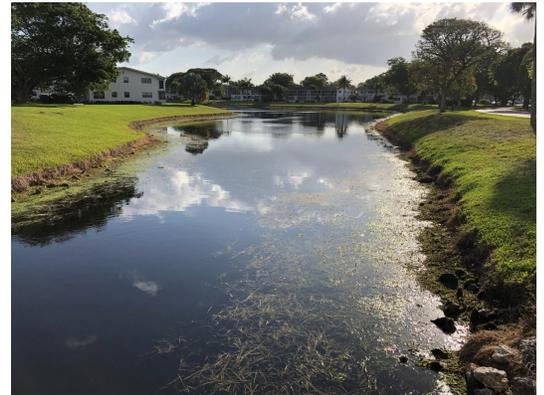
Site: 2

**Comments:** Treatment in progress

Minimal amounts of algae and were visible at this time. The aquatic plant, Vallisneria is undergoing annual treatments and continues to decompose.

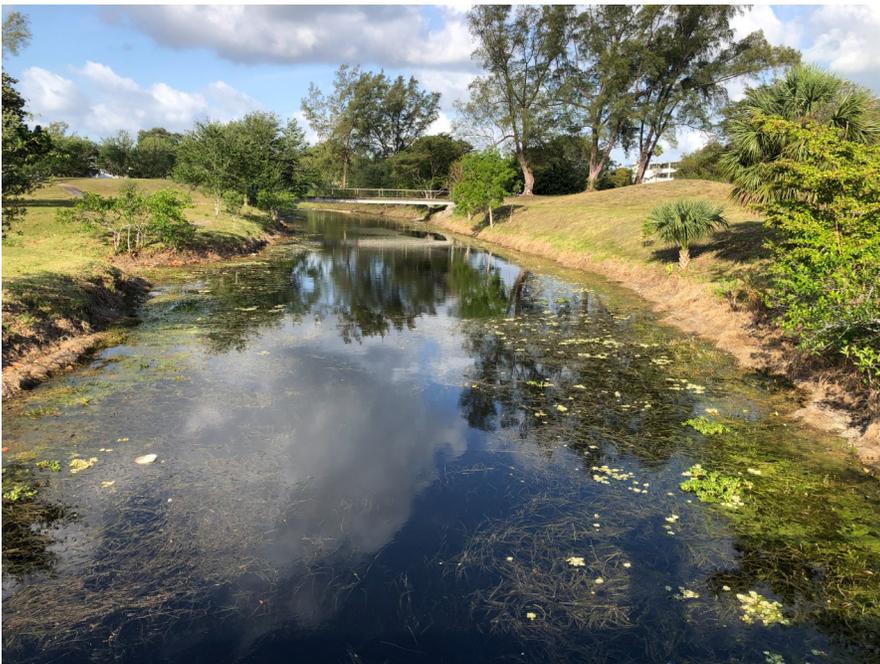
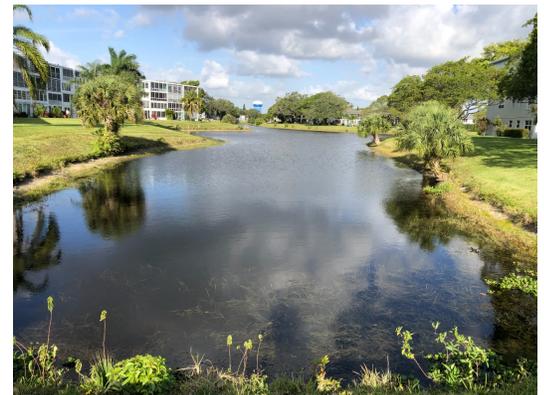
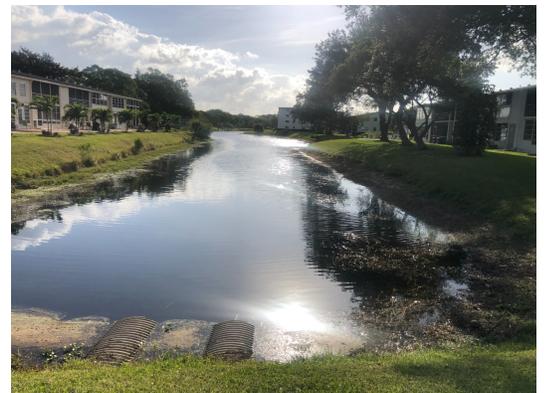
Site: 4

**Comments:** Treatment in progress

Dead torpedo grass has decomposed. Traces of Water lettuce were observed near the shoreline. Algae was observed on the decomposing vallisneria and hygrophila.

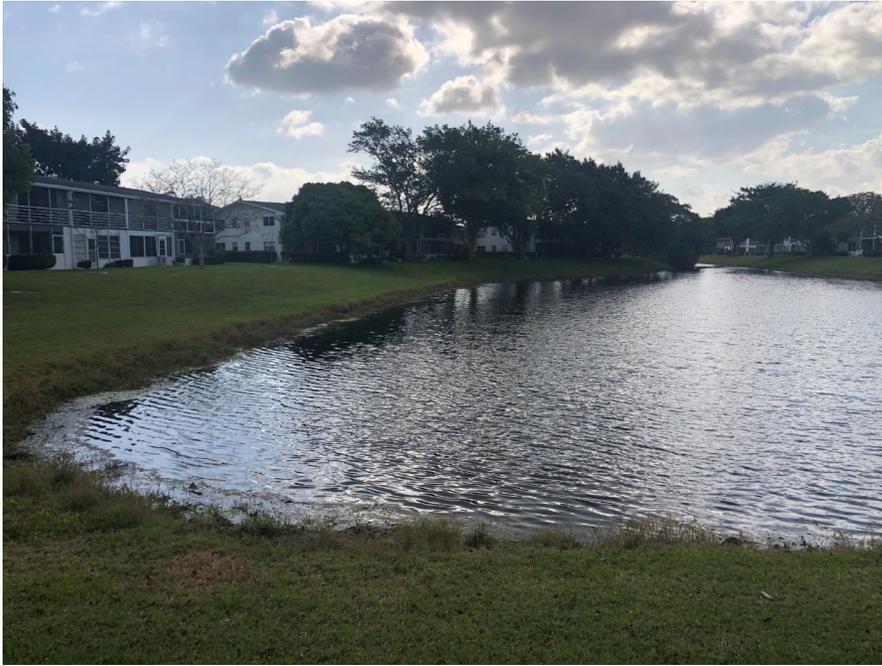
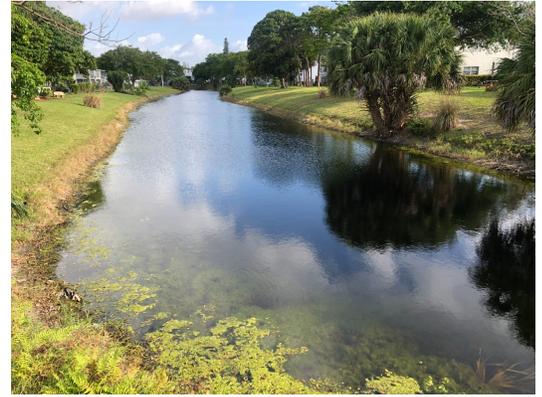
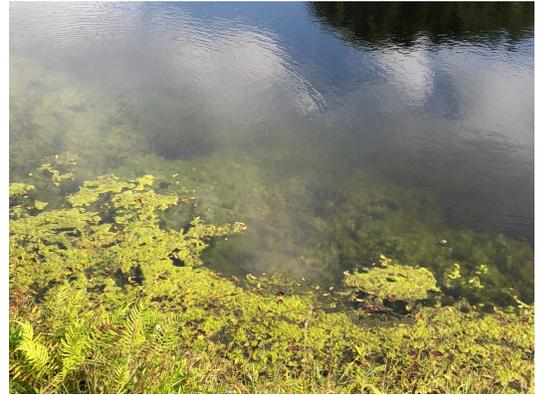
Site: 5

**Comments:** Requires attention

Torpedograss was observed along the shoreline. A moderate amount of Chara was observed below the surface. Some surface algae was seen along the shoreline. Several snakeheads were observed along the shoreline.

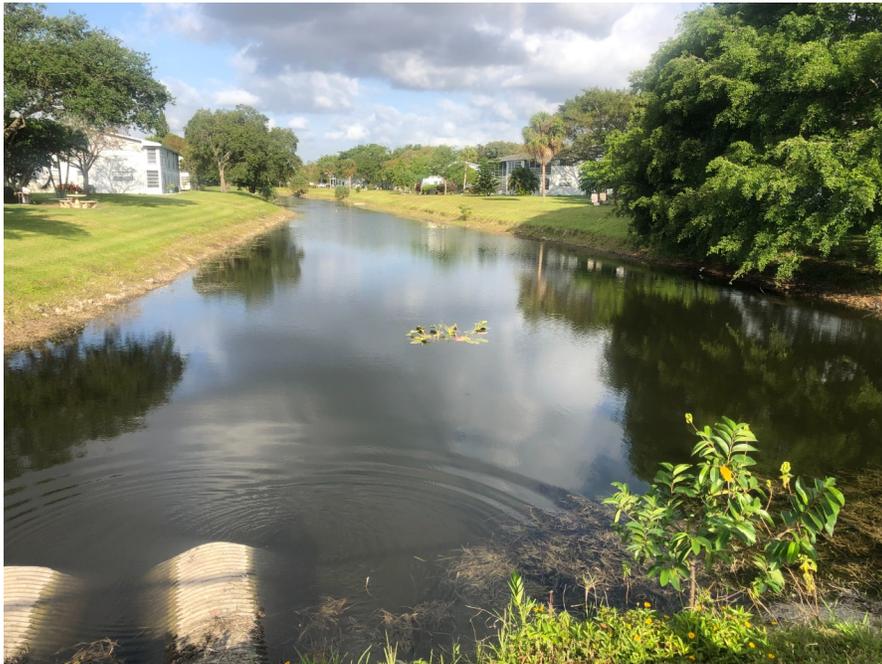
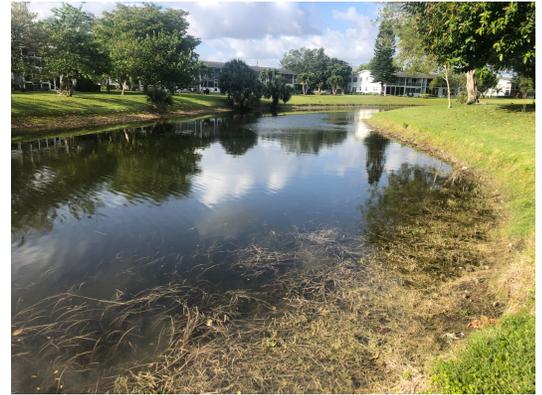
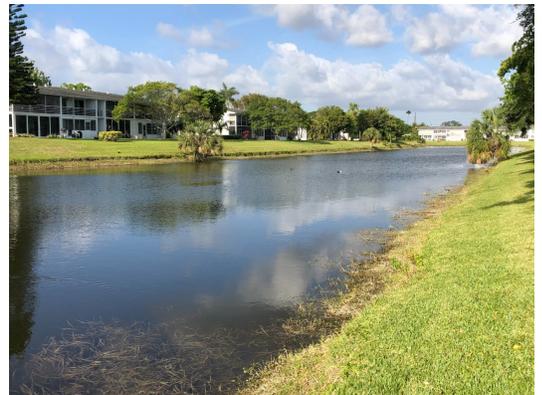
Site: 6

**Comments:** Treatment in progress

Dead Torpedograss was observed along the shoreline and continues to decompose. Vallisneria is dying and decomposing. Small patches of spatterdock (similar to a water lily) were seen.

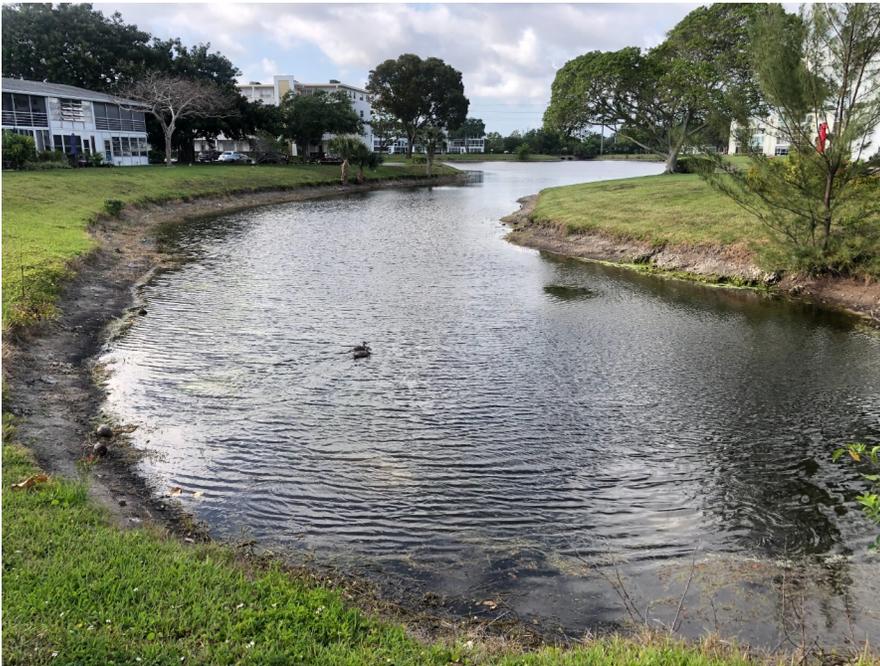
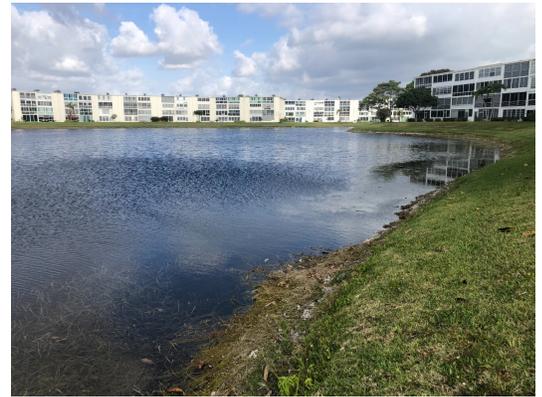
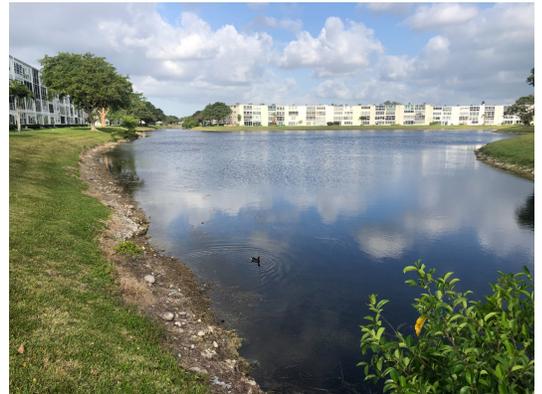
Site: 7

**Comments:** Treatment in progress

Traces of torpedograss and algae was observed along the perimeter of the lake. Vallisneria growth continues to be treated.

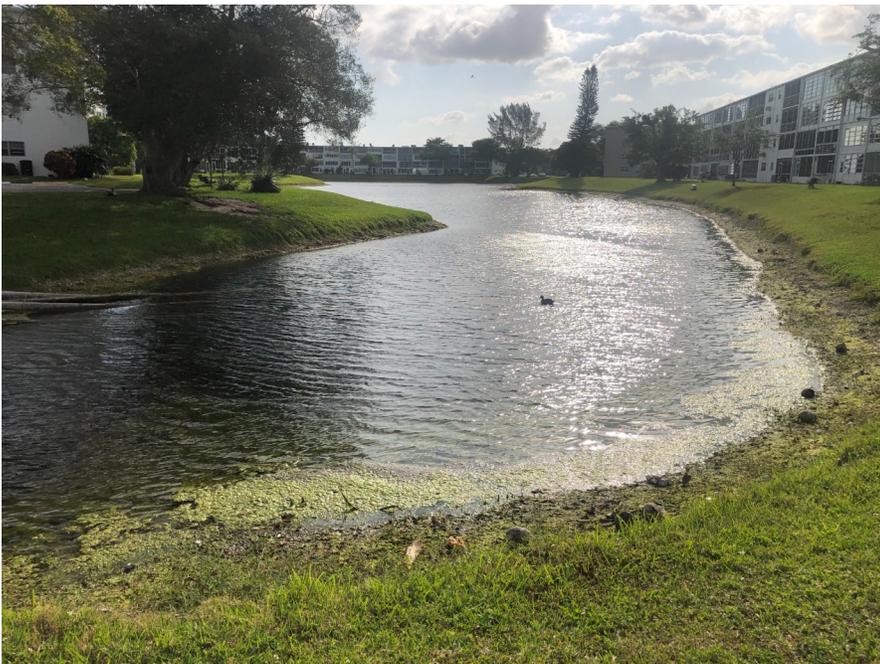
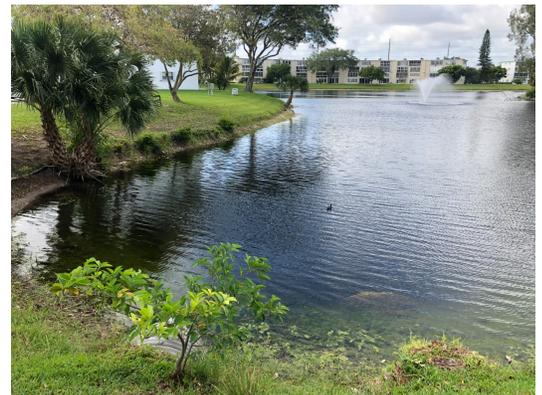
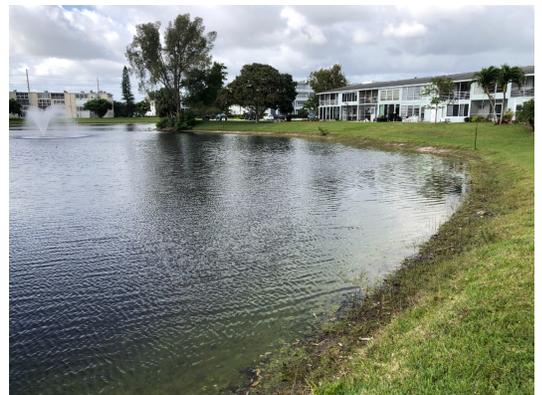
Site: 8

**Comments:** Site looks good

Traces of surface algae and torpedograss was observed along the shoreline. Chara was also observed below the surface.

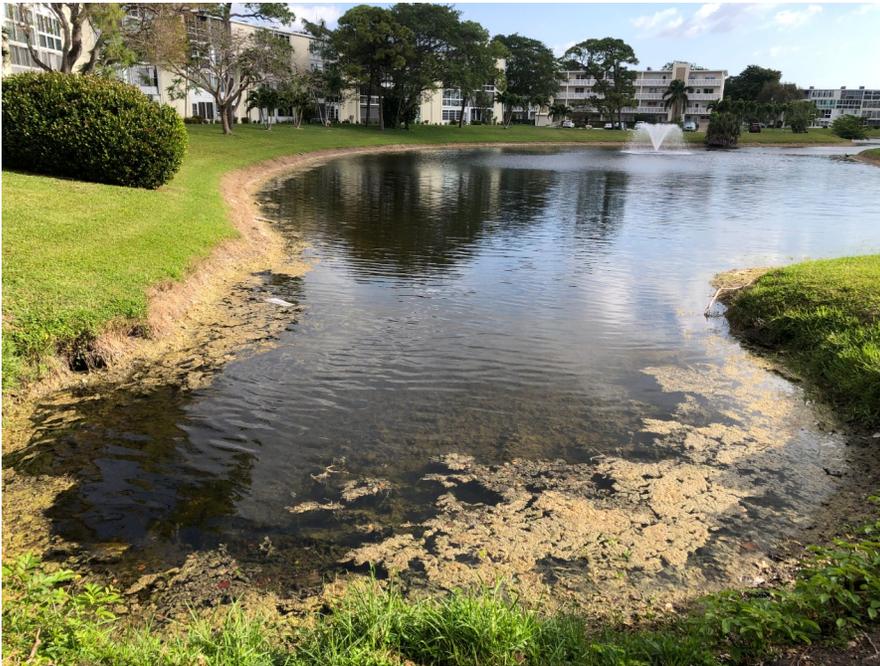
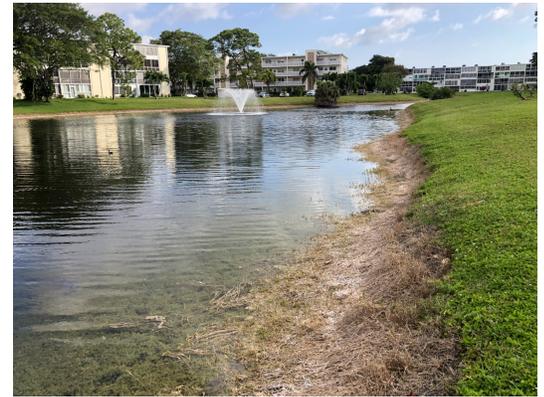
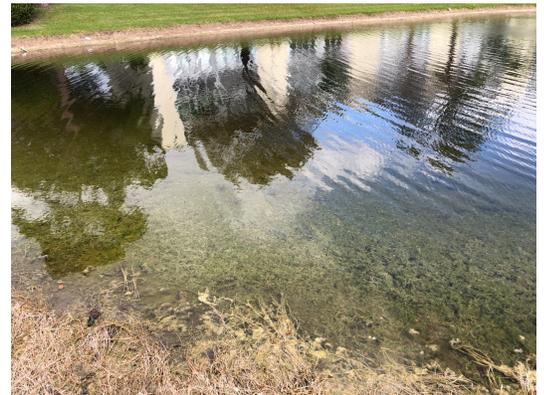
Site: 9

**Comments:** Treatment in progress

Torpedo grass has been treated and is dying/decomposing along the shoreline. Chara (a macrophytic algae) can be seen below the surface.

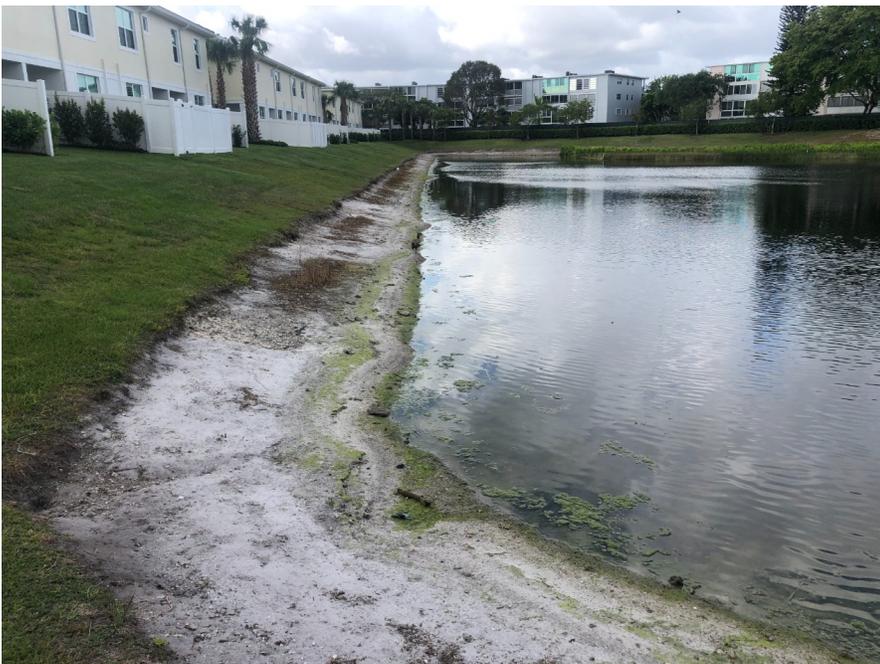
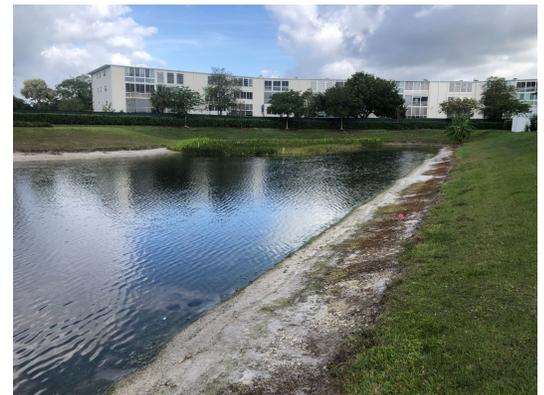
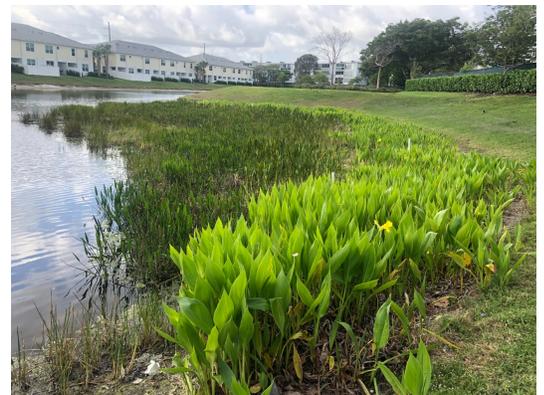
Site: 10

**Comments:** Site looks good

Lake bank the native plant bacopa has been treated. Traces of algae were observed. Littoral plants are doing well and have recovered.

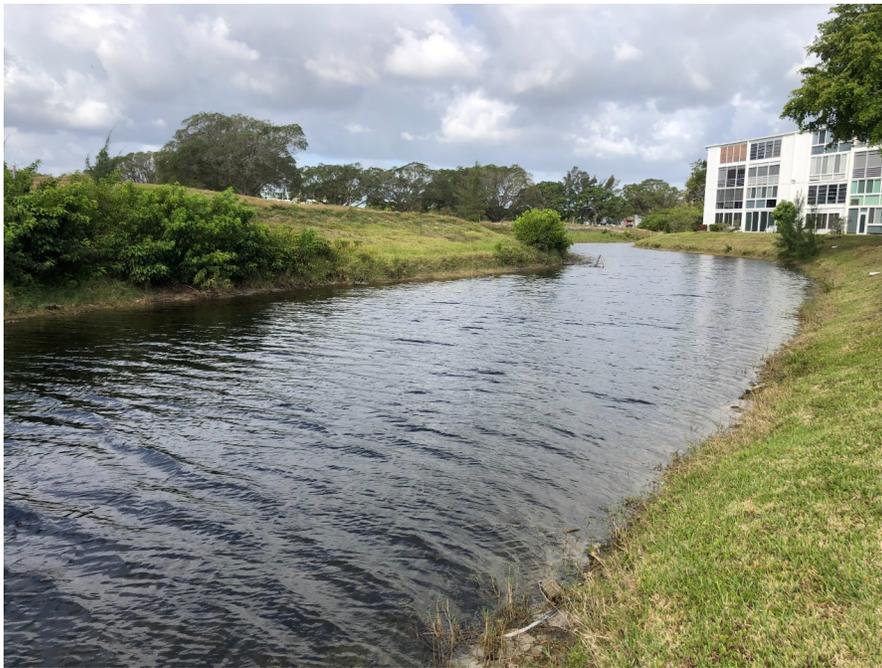
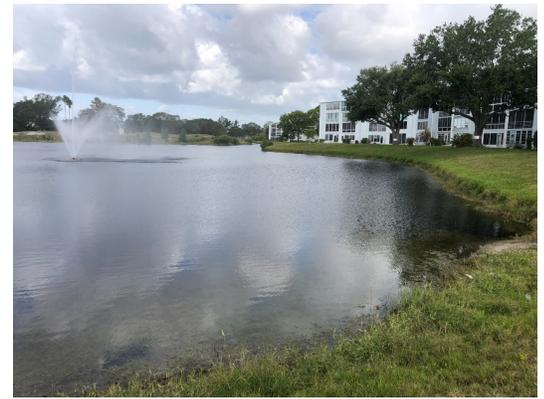
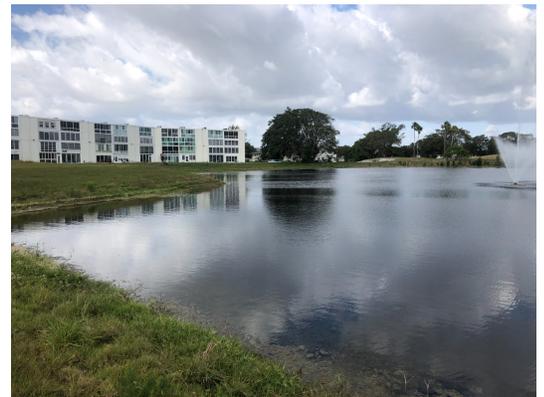
**Site: 11**

**Comments:** Site looks good

Traces of algae and torpedograss were seen. Small non-native trees along the shoreline should be cut down and removed by the landscape company.
