Century Village East Master Waterway Inspection Report

Reason for Inspection: Quality Control

Inspection Date: 04/27/2020

Century Village East Master Management
Mr. Robert Streater
3501 West Drive
Deerfield Beach, FL 33442

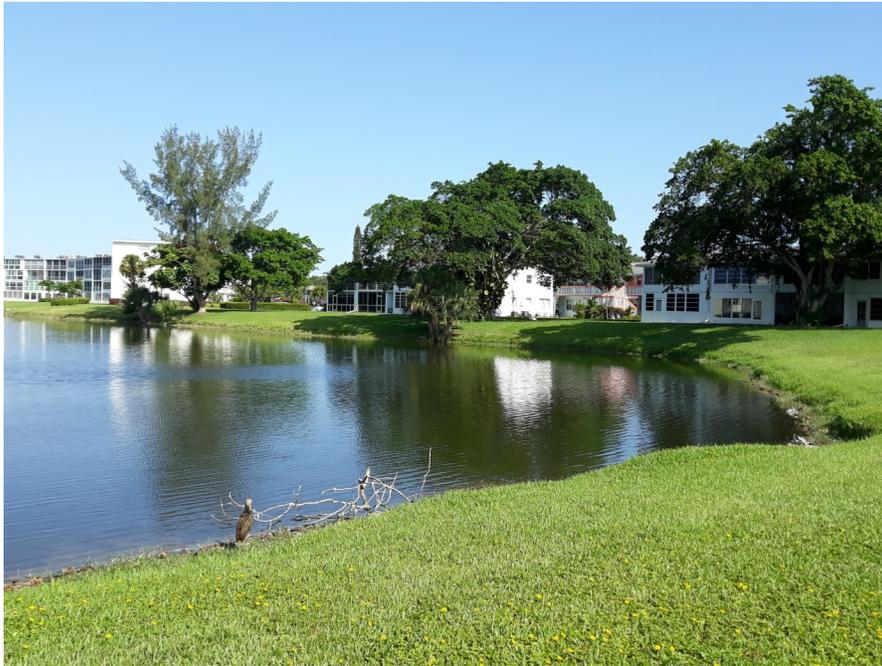
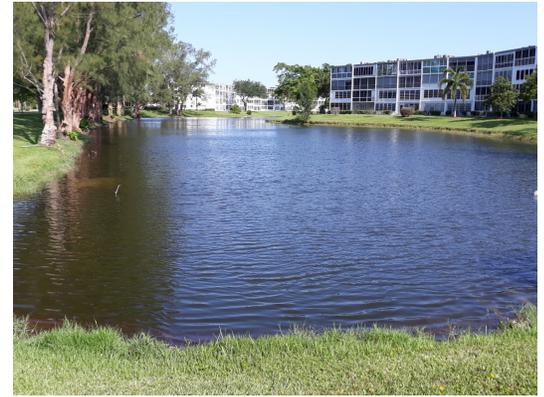
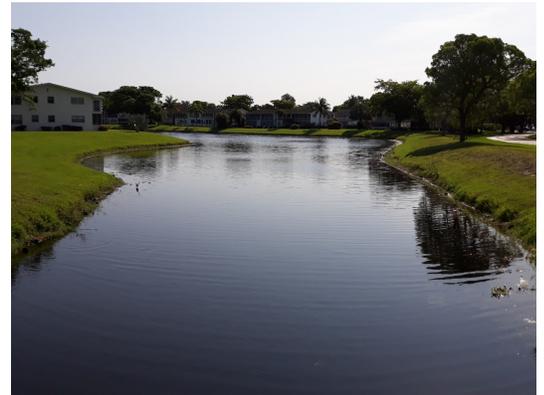
Site: 2

Comments: Site looks good

Traces of Torpedo grass, Alligator weed, and Water Hyacinth were observed along the shoreline, No algal issues were visible at this time.

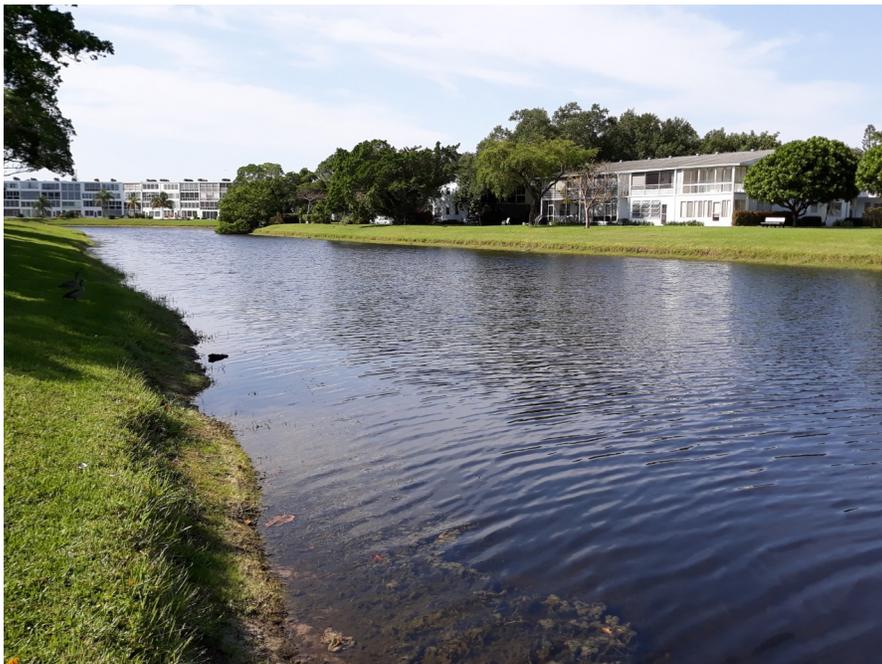
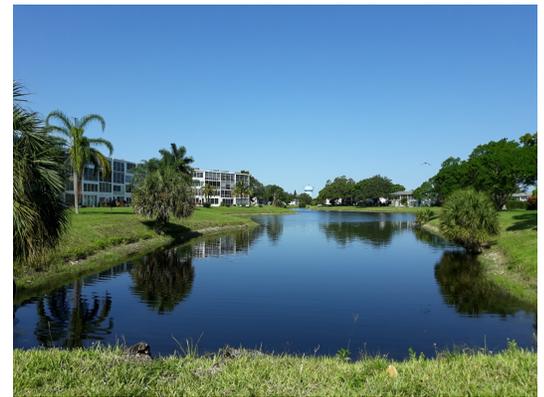
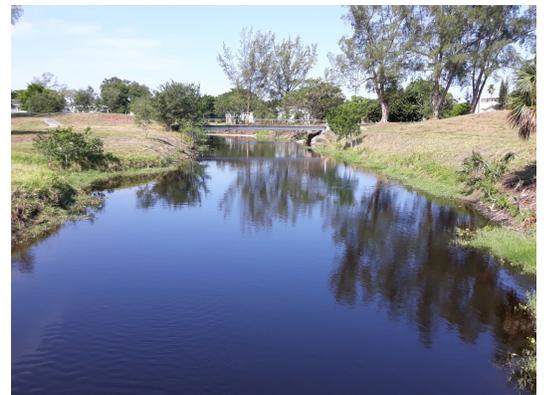
Site: 4

Comments: Treatment in progress

Traces of scattered Torpedo grass were observed along the shoreline. Traces of Water Hyacinth were observed near the shoreline. Traces of East Indian Hygrophilla were observed below the surface. No algal issues were visible at this time.

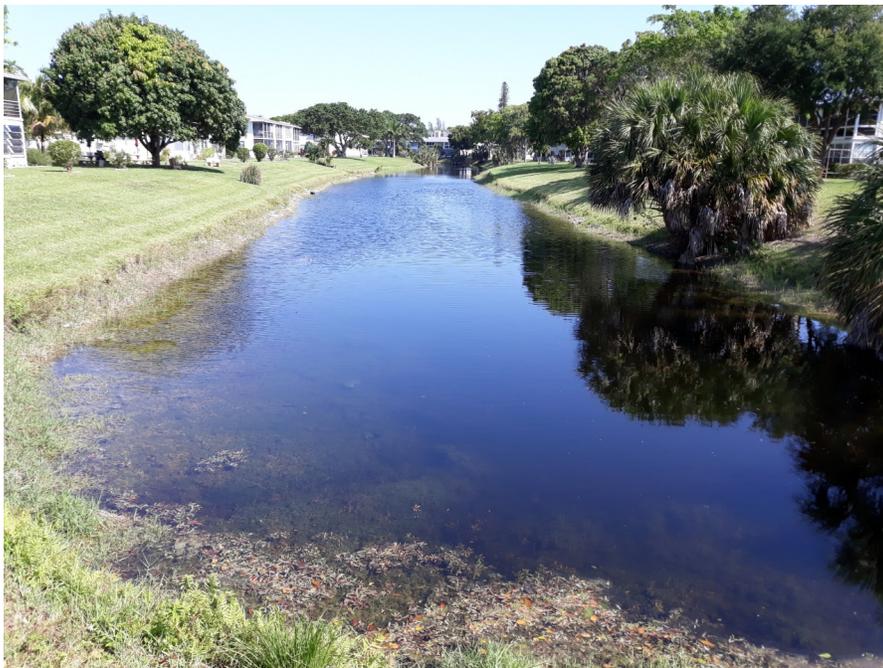
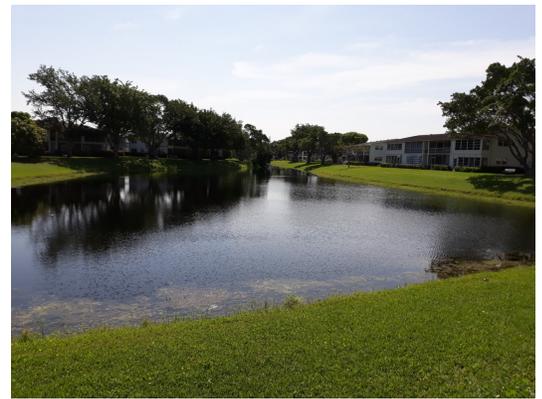
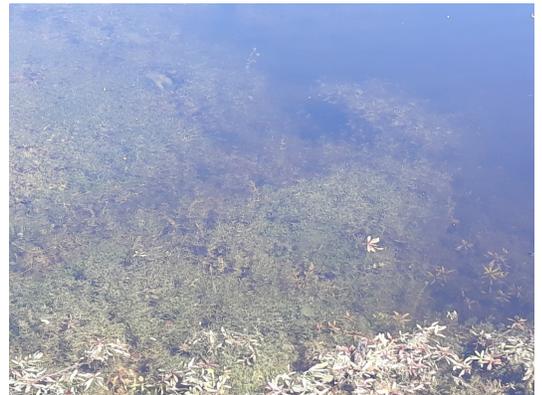
Site: 5

Comments: Treatment in progress

Traces of Torpedo grass were observed along the shoreline. A moderate amount of Chara were observed below the surface. Traces of scattered East Indian Hygrophilla were observed below the surface. No algal issue was visible at this time.

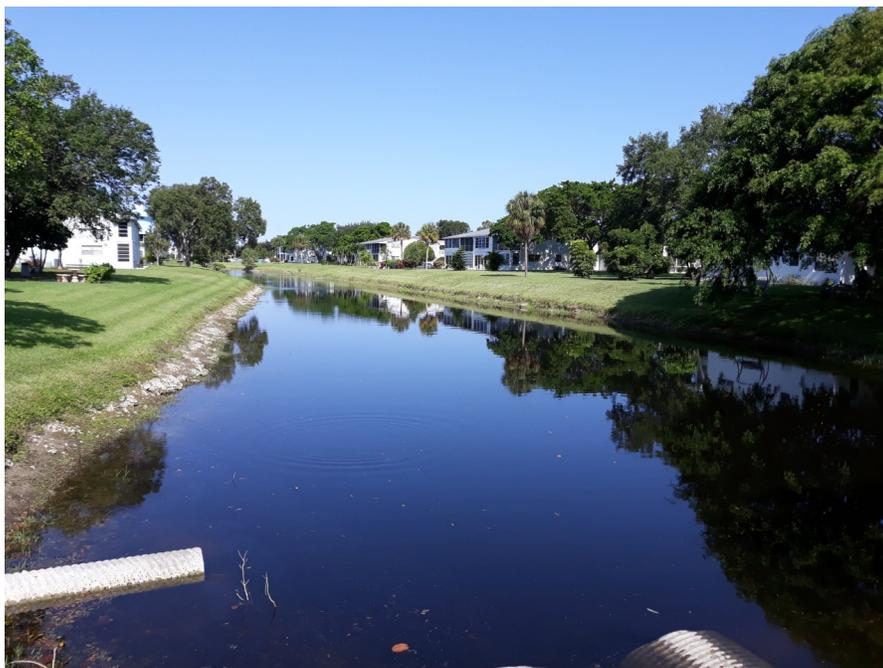
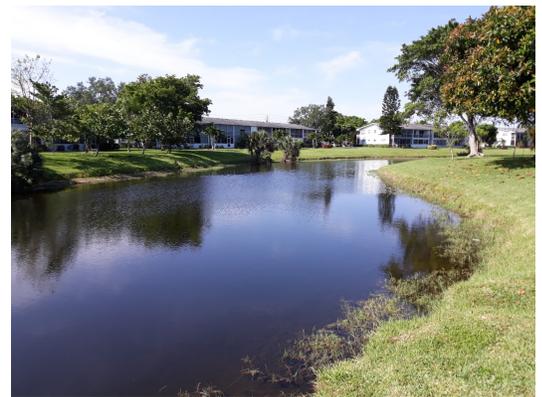
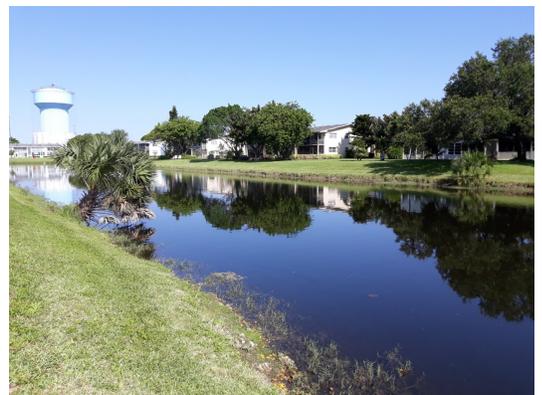
Site: 6

Comments: Site looks good

Traces of scattered Torpedo grass were observed along the shoreline. Traces of windblown East Indian Hygrophilla were observed at the surface. No algal issue was visible at this time.

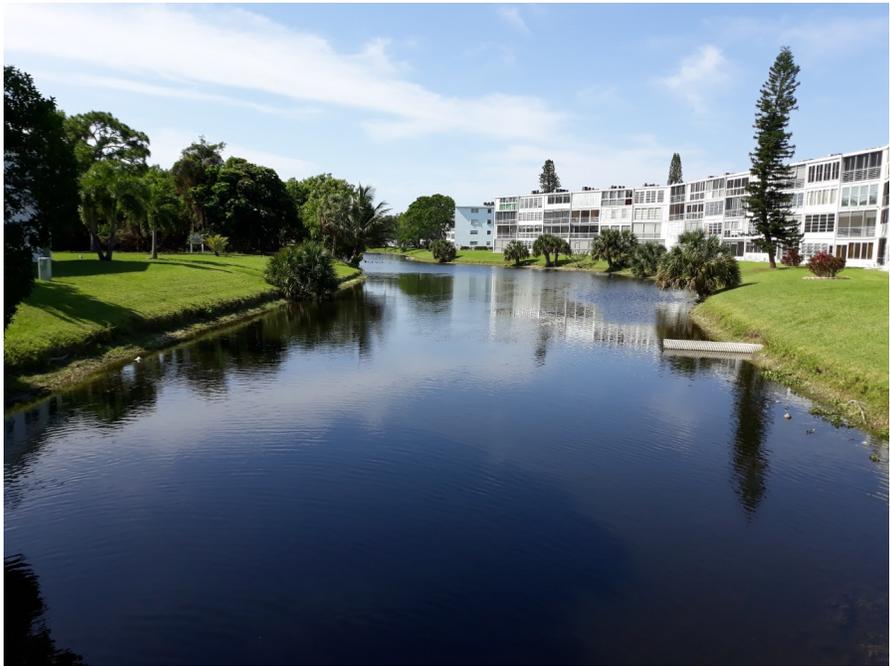
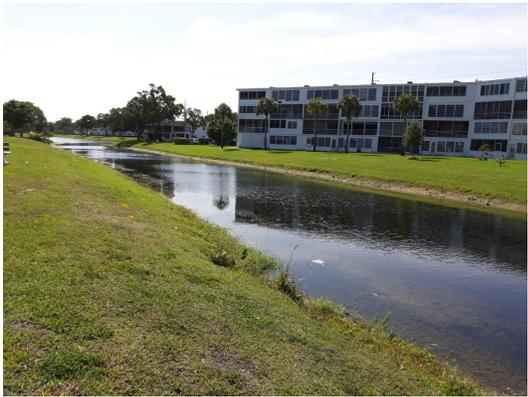
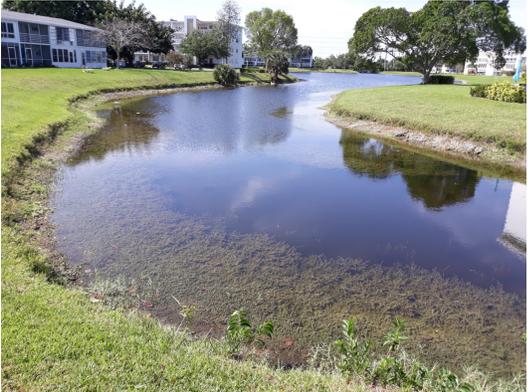
Site: 7

Comments: Treatment in progress

Traces of Torpedo grass was observed along the perimeter of the lake. No algal issue were visible at this time. Hydrilla was seen at various locations throughout the lake. Treatments are being to control its growth.

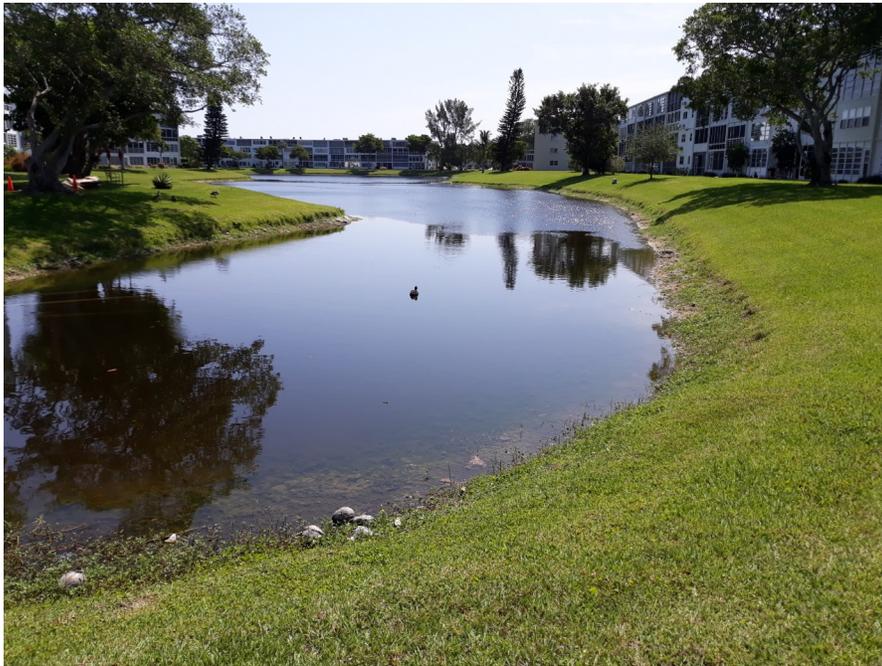
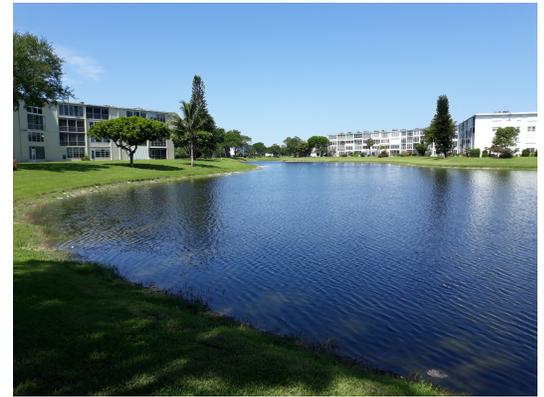
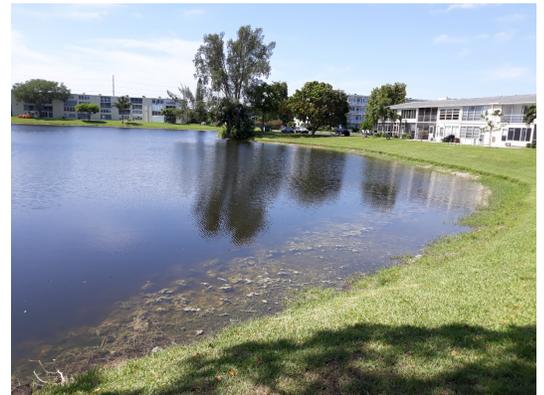
Comments: Normal growth observed
Traces of Torpedo grass were observed along the shoreline.

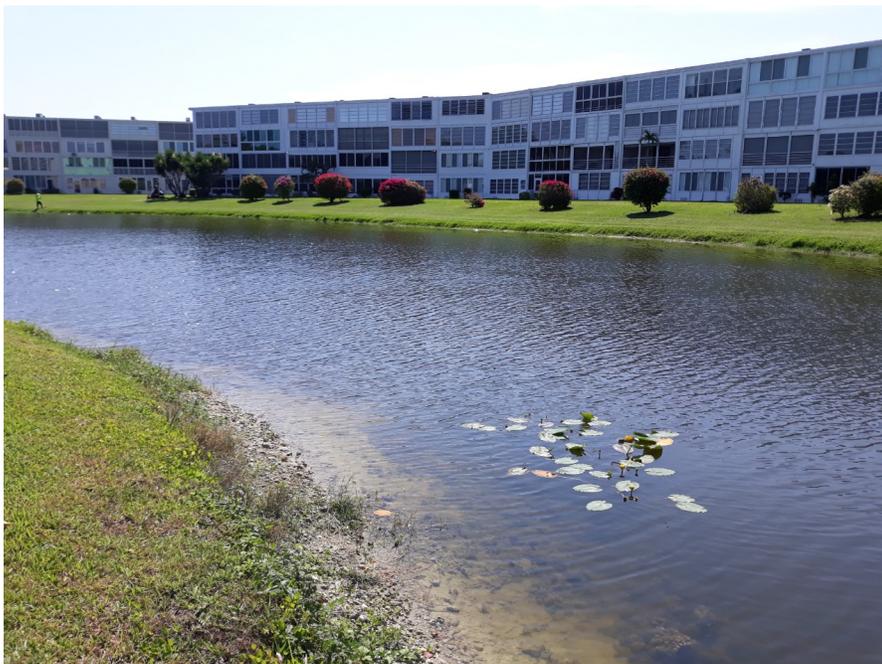
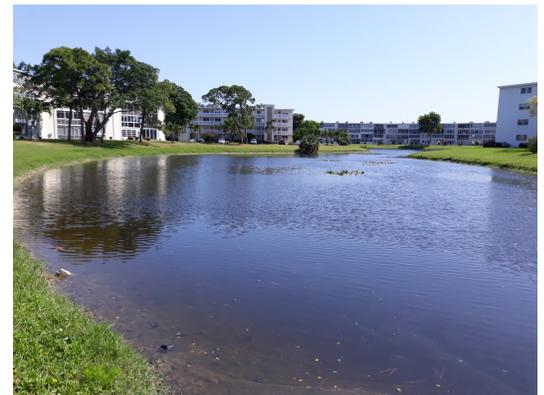
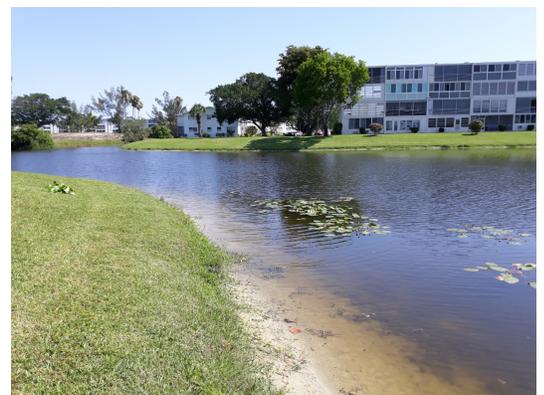
Site: 9

Comments: Site looks good
Traces of Torpedo grass were observed along the perimeter of the lake. No algal issues were visible at this time.

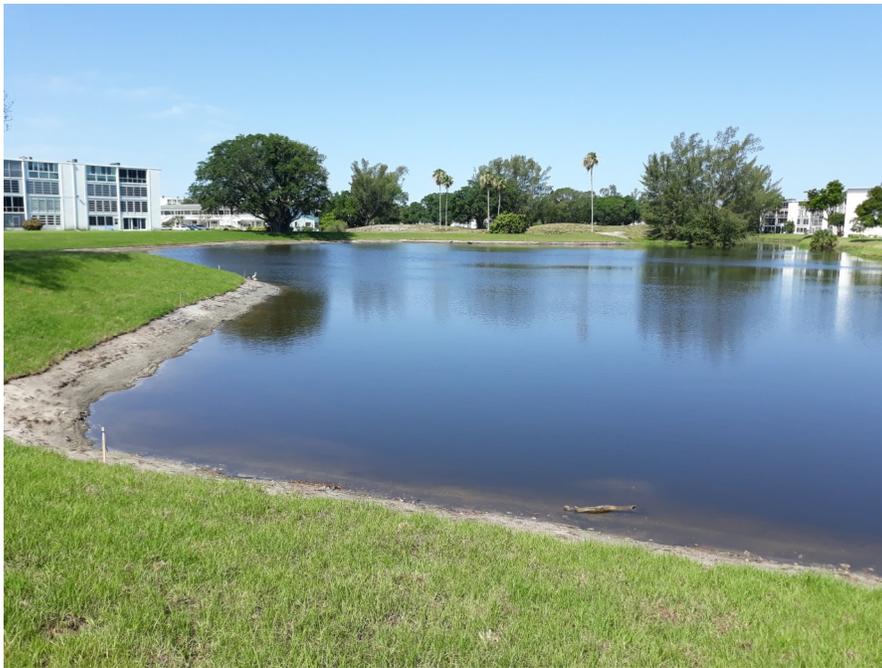
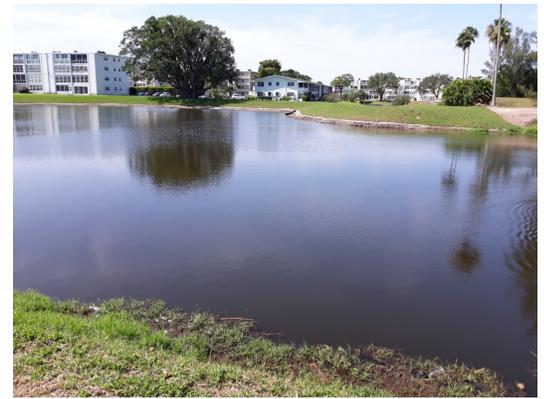
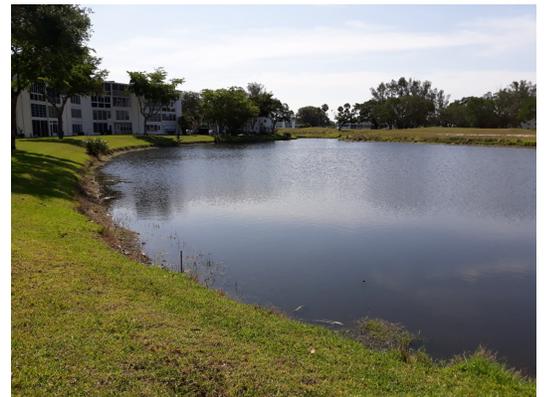
Site: 11

Comments: Site looks good

Traces of torpedograss and algae
